### **ROMEO PIER UPDATE: REPORT ON PERMITS, BIDS, FUNDING OPTIONS, AND PROPOSED TIMELINE**

# **ROMEO PIER EVALUATION REPORT**

**Prepared For  
SAN MATEO HARBOR DISTRICT  
El Granada, California**

**Prepared By  
MOFFATT & NICHOL ENGINEERS  
3000 Citrus Circle, Suite 230  
Walnut Creek, California**

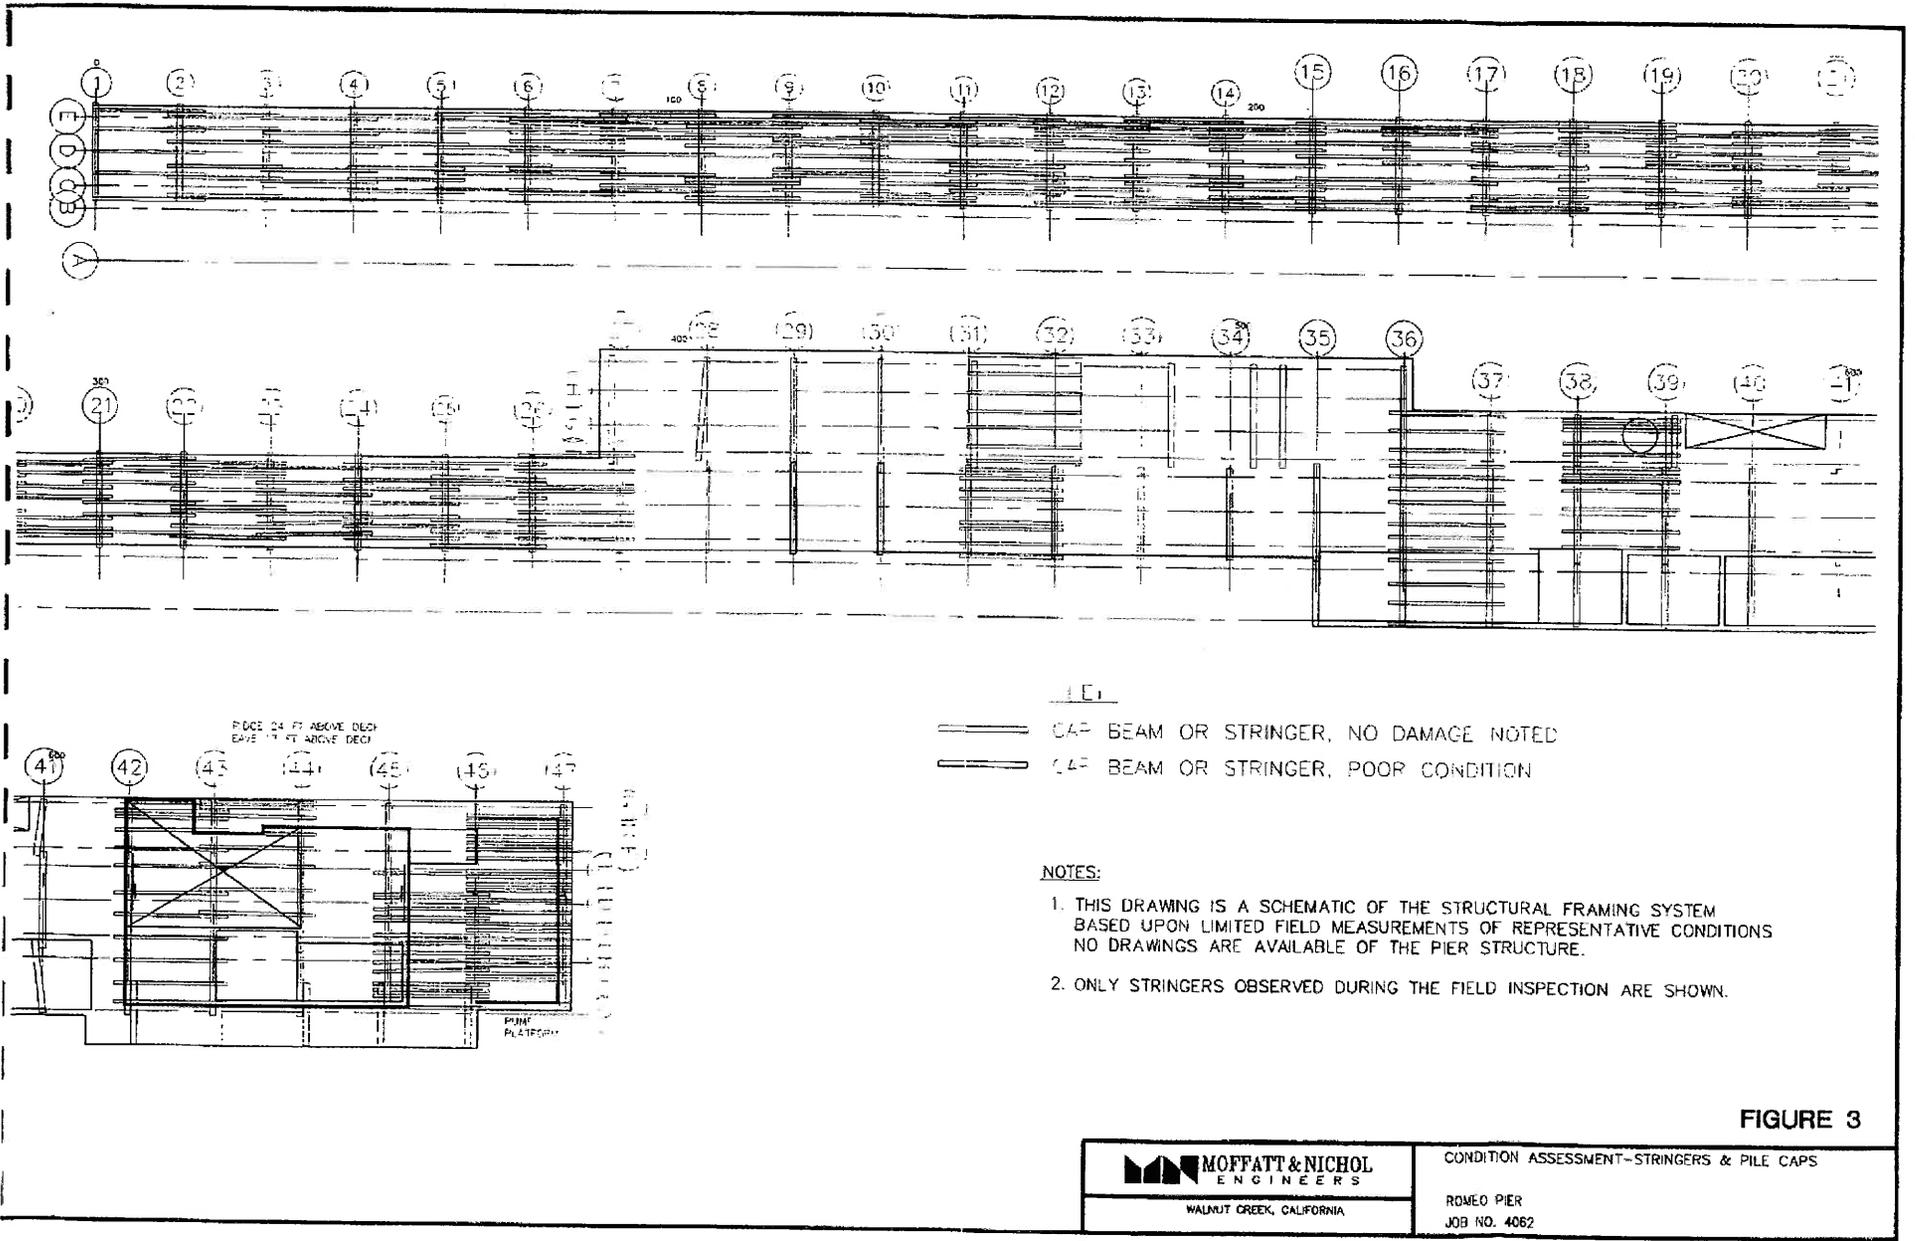
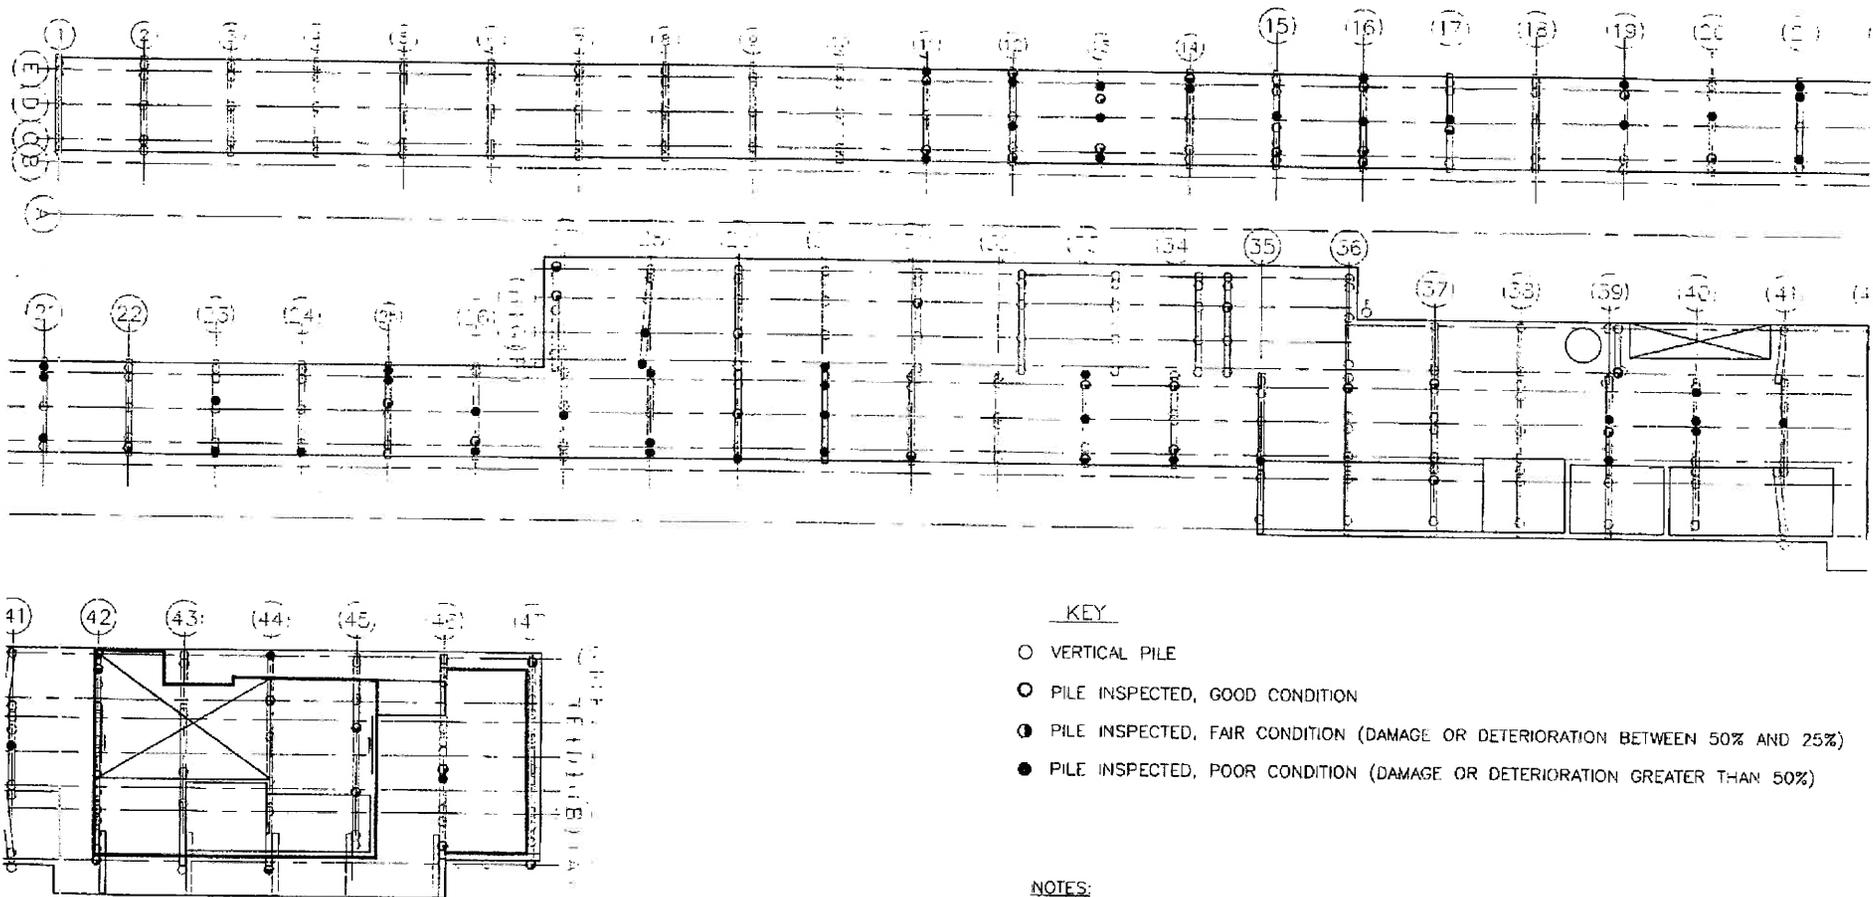
**FIGURE 4**

Piles are generally between fair and good condition. All pile cores indicated piles are treated with creosote. Many of the older piles have been replaced with 'sister' piles located directly beside the old pile. These piles were driven next to the existing pile and then pulled into place under the existing pile cap. The piles replaced with sister piles were typically not removed. A total of 50 piles are identified for replacement as shown in Figure 4.

<b>MOFFATT &amp; NICHOL</b> ENGINEERS WALNUT CREEK, CALIFORNIA	CONDITION ASSESSMENT: PILES
	ROMEO PIER JOB NO. 4062

- **Piles:** Approximately 50 piles require replacement. Replacement of these piles would require removal of members supported by the piles or providing temporary support. The piles can be driven adjacent to the existing piles and then pulled in to align with the cap.

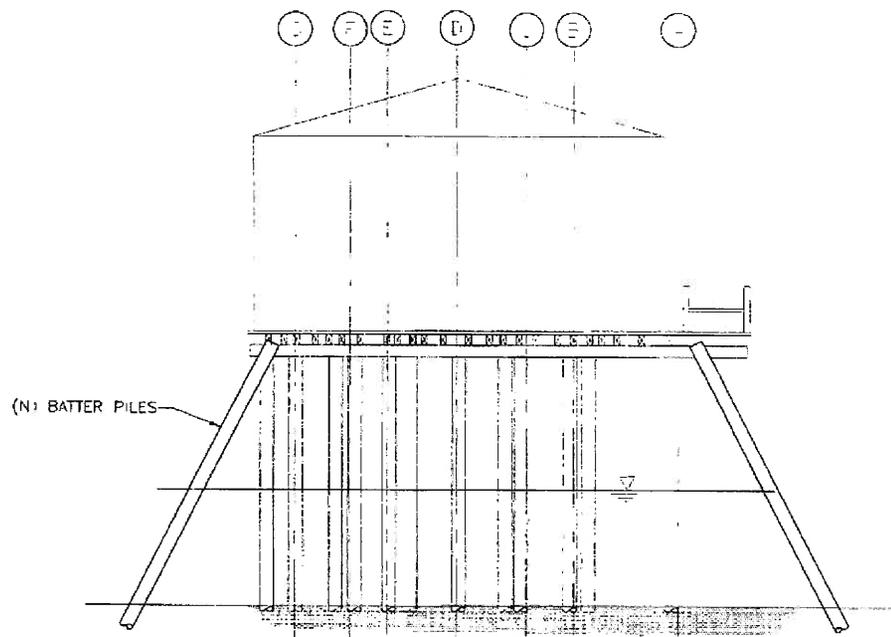
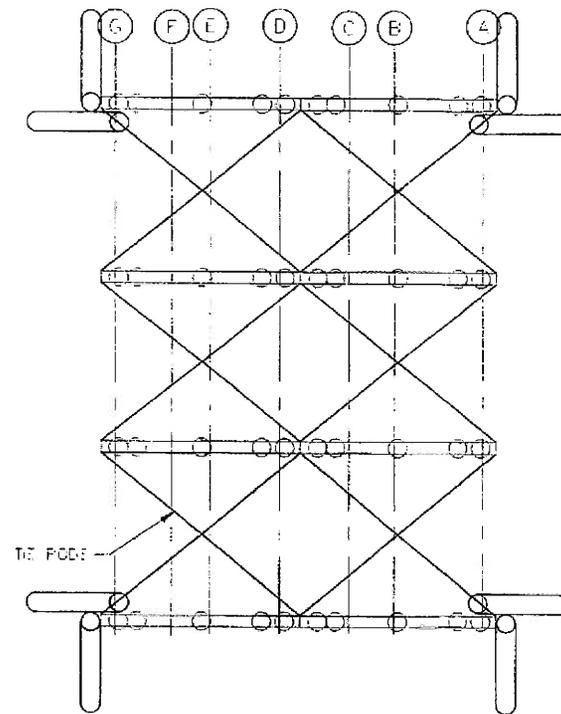
FIGURE 8

LATERAL LOAD RETROFIT  
ALTERNATIVE 2 - BATTER PILES  
ROMEO PIER  
JOB NO. 4062

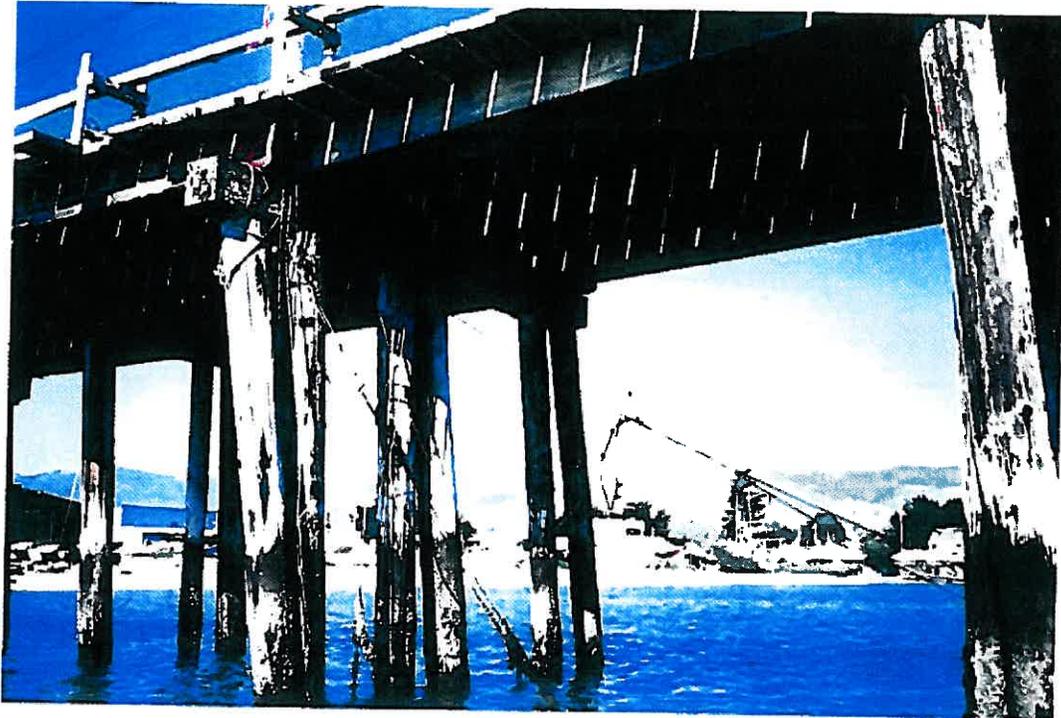
VIEW OF PIER FROM WATER AT GRIDLINE 20 SHOWING FRAMING PATTERN LINE  
(NOTE CABLES HOLDING PIER)  
PHOTOGRAPH NO. 3

This condition was not calculated; however, it is apparent that the structure is deficient with regard to lateral capacity. Lateral movement of the pier from general vehicular use on the pier, as well as impact of the boats moored to the structure is easily felt on the pier.

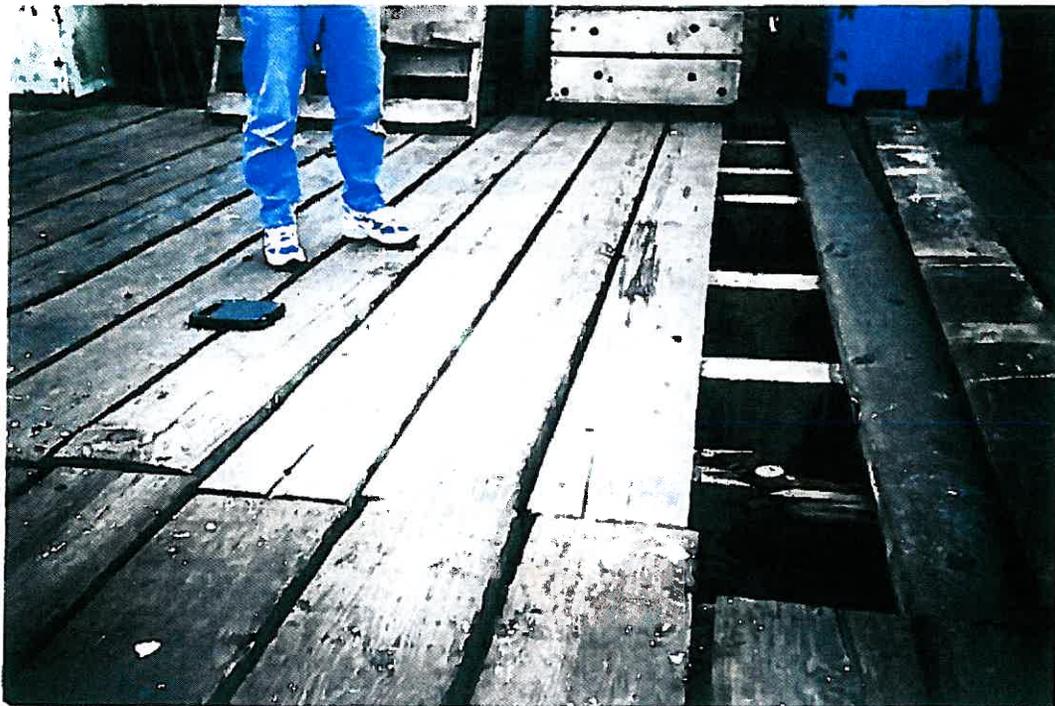
STRINGER AND PILE CAP INSPECTION  
PHOTOGRAPH NO. 6

Stringers are generally in good condition. Approximately 9 percent (35 stringers out of 400 total) are recommended for replacement. These stringers are spongy with significant deterioration, and as such, pose either a current safety hazard or will pose this level of hazard in the near future. Wet stringers also occur under the icemaker as discussed in Section 4.2.1. Stringers identified for replacement are shown in Figure 3.

Pile caps are also in good condition. A total of 80 lineal feet of cap material, out of approximately 1,230 feet, is recommended for replacement. Those caps recommended for replacement show significant deterioration. One specific area of deterioration is located under steel plates placed on the deck at Grid Line 29. These plates have been placed at this location because the cap is no longer capable of safely carrying load. Pile caps identified for replacement are shown in Figure 3.

- **Stringers:** Approximately 35 stringers require replacement. This work would require removing the existing planks and stringers and installing new 6x12 stringers. A small number of new stringers could be installed to reduce the maximum deck plank spans.

- **Pile Caps:** Approximately 80 lineal feet of pile caps are in need of replacement. This work would require removing the existing deck planks, stringers and caps. The new 12x12 caps must be attached to the piles with drift pins or bolted plate connections.

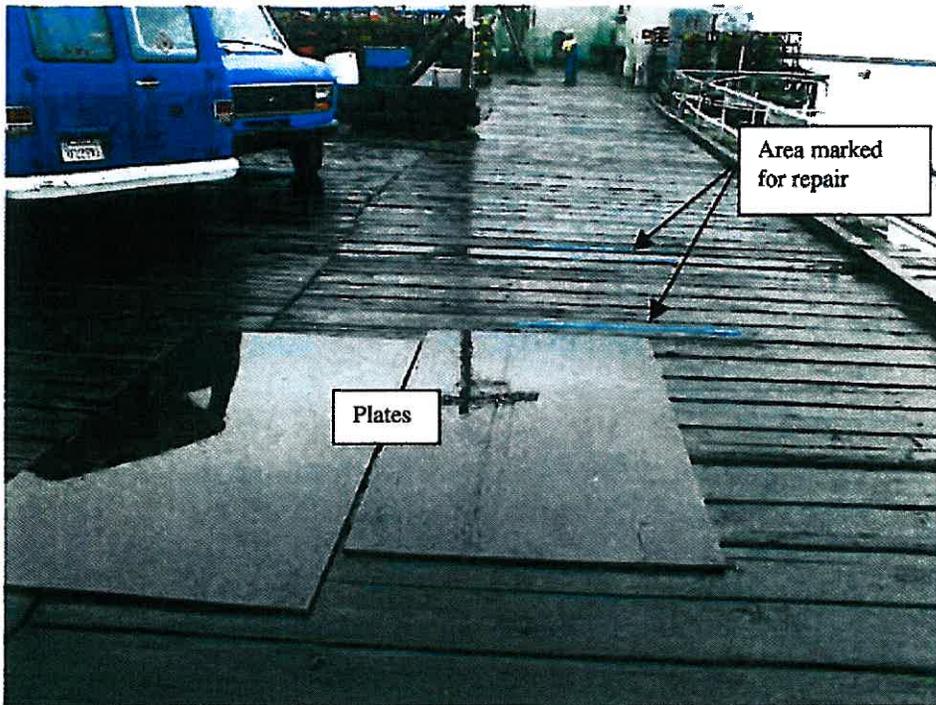
**Photograph 4 – Plates over Damaged Pile Cap**

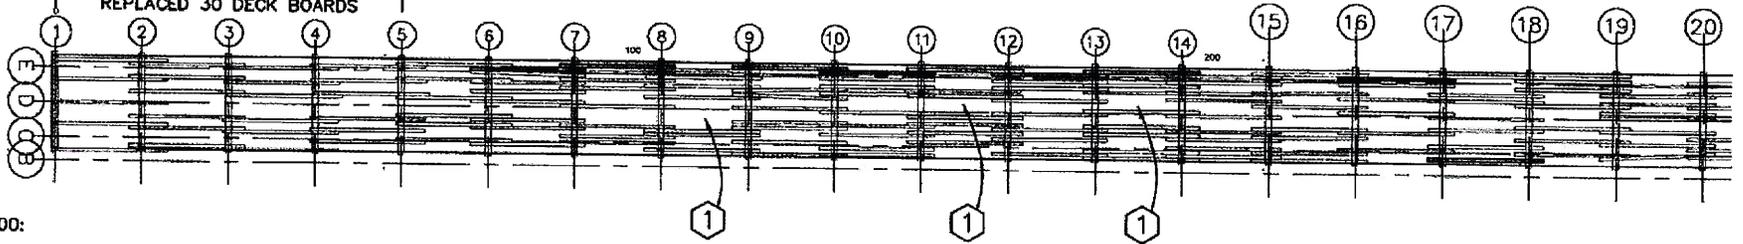
REPLACED 4 PILE CAPS  
REPLACED 14 STRINGERS  
REPLACED 30 DECK BOARDS
