## **CONDITION & VALUE SURVEY**

## **M/V 32' Harbor Patrol**

**Report #:** 26-158R  
**Date:** September 2, 2026  
**Owner:** San Mateo County Harbor District  
**Survey Requested By:** Chris Tibbe, [ctibbe@smharbor.com](mailto:ctibbe@smharbor.com)  
**Where Surveyed:** Clipper Yacht Harbor & Safe Harbor Sausalito  
**Afloat/Hauled:** Afloat & while hanging in the Travelift slings  
**Type:** Harbor patrol boat  
**Service:** Commercial/institutional  
**Home Port:** Pillar Point, CA

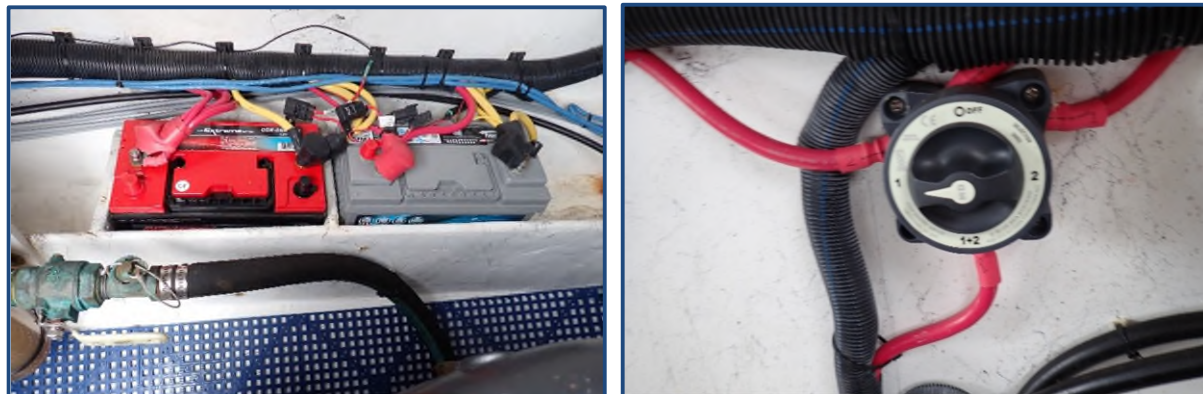
Two identical but separate DC electrical systems are aboard the vessel; two Northstar GP31 AGM 105-AH batteries power the engine-starting systems, and two Odyssey GP27 12-volt AGM 92-AH batteries are used for the domestic system. Both systems are routed through Blue Sea Systems four-position vapor-tight battery switches, the engines' wiring harnesses, and the distribution panelboards. The two separate systems can be paralleled via the vapor-tight battery switches.

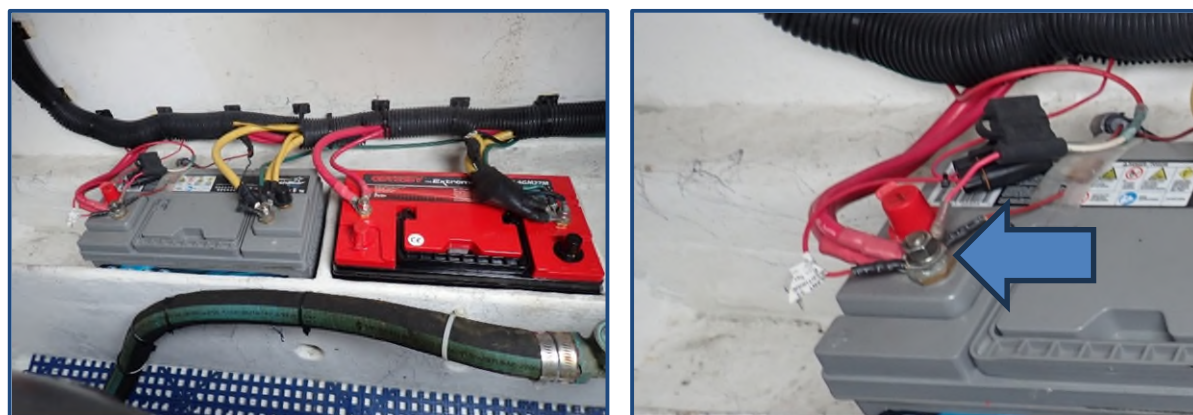
The four batteries are satisfactorily and securely installed, within custom-built, acid-proof battery compartments. The batteries were replaced recently; they appeared without casing anomalies, cracking, or bulging, and to the extent they could be tested, maintaining an adequate charge.

The engine-starting batteries had extraneous conductors, and more than four ring terminals were connected to their ungrounded battery post, which does not meet the guidelines of ABYC E-10 Storage Batteries:

*10.8.4.1 A maximum of four conductor terminals shall be installed on a single battery terminal (e.g., stud, post)*

Perhaps, rewiring these conductors, and powering them from a single buss bar, which can be disconnected via the battery switches is suggested.

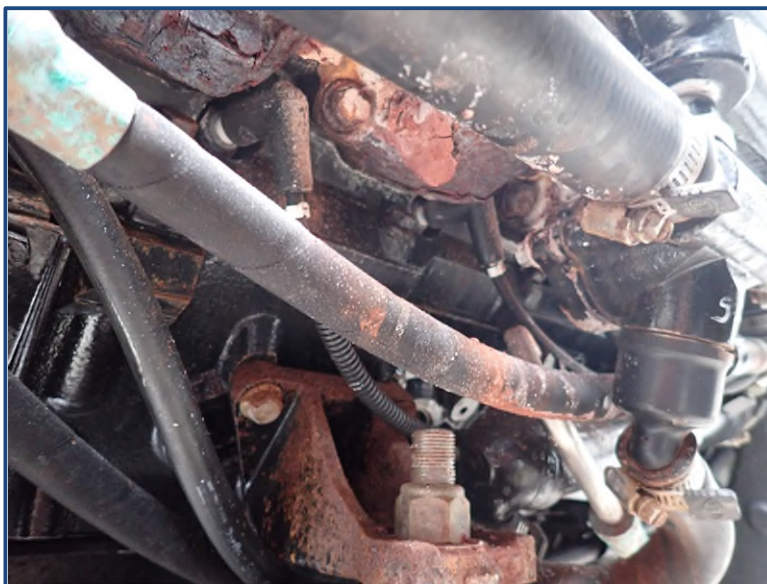
Aside from heavy rusting on the port engine's outboard exhaust manifold mounting flanges, the remainder of the exhaust manifolds, and the engines were in reasonably good cosmetic condition, without noticeable failures of their factory installed anticorrosive coating, or significant corrosion on the machinery housings. The engines' oil was checked, and found topped-off, and of normal quality. There were no signs of noticeable cooling water, oil, or fuel leaks observed. Aside from some minor wear showing on the serpentine belts, the hoses and high-pressure oil lines were without cracking, chafe, or wear.

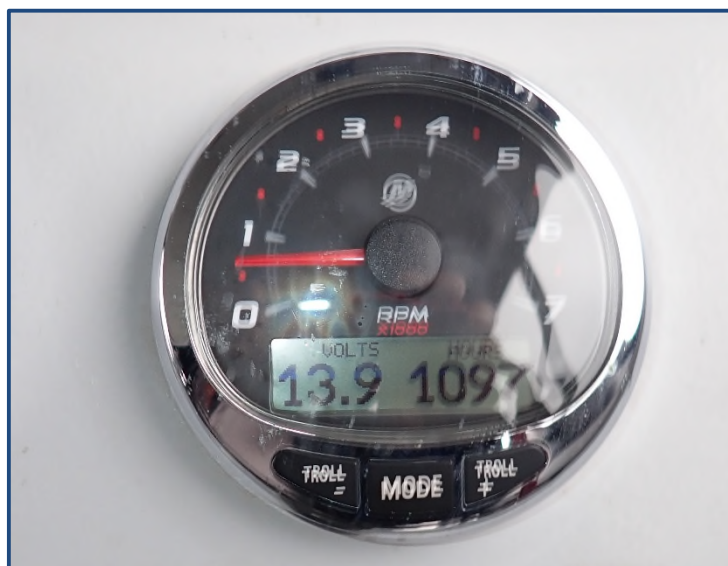
The starboard engine started quickly, and pumped adequate cooling water, with no smoke in the exhaust. Once this engine warmed to operating temperature, it idled and shifted smoothly, but with some delay, but needing to be induced by increased engine RPM. The starboard engine gauges and alarms appeared to be functioning normally, to the extent they could be tested. The port engine was difficult to start, and after several attempts, it was determined the engine would not run. No testing of the port engine or its control systems was performed.

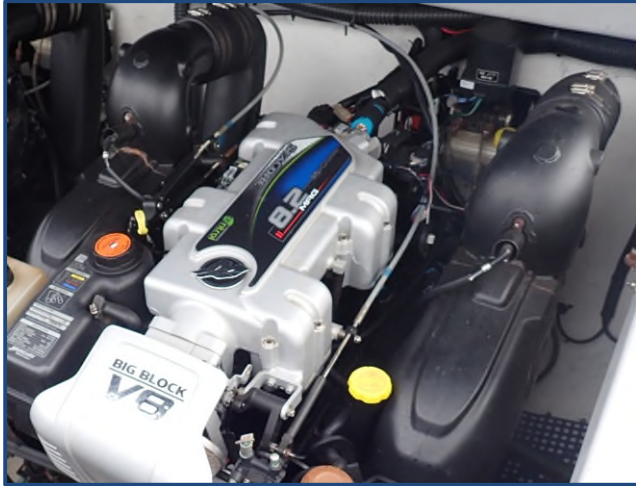
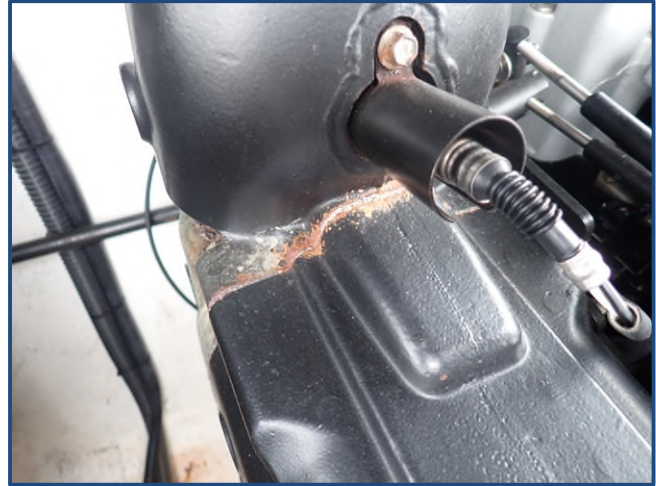
The engine exhaust is routed through center-rise raw-water cooled manifolds, mixing elbows, flexible exhaust hose cuffs, aluminum Y-pipes, and it exits through the outdrives, below the waterline. The mixing elbows showed some indication of external raw-cooling-water seepage at the gasketed flanges. External raw-water cooling leaks can be indications of internal leakage, which could result in engine water ingestion, and permeant, and serious mechanical damage. Replacing the leaking manifolds, elbows, and corresponding gaskets is recommended.

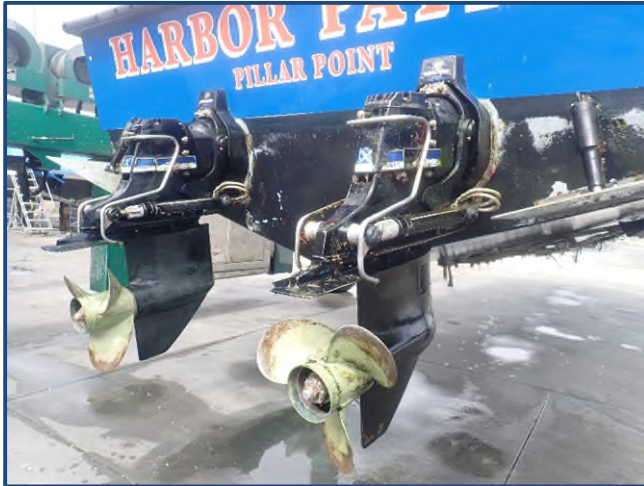
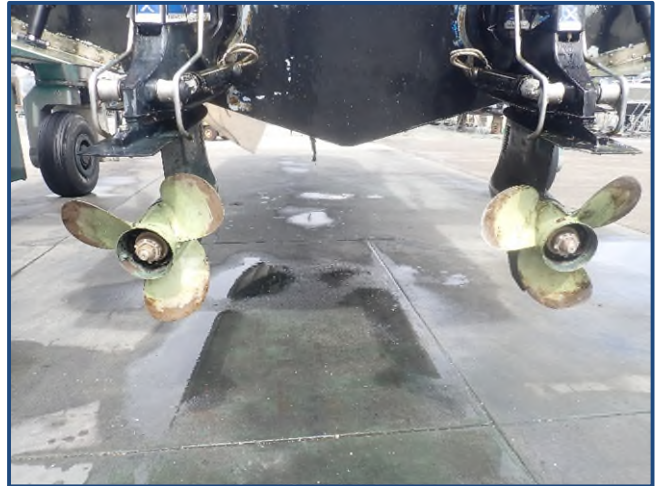
The trim tab planes and their actuators were well-secured to the transom, without pitting or other forms of corrosion. The outdrives were in mostly good cosmetic condition, aside from a broken corner of the starboard drive's cavitation plate. Their tilt & trim cylinders were in good condition, without signs of fluid leaks, or pitting of the stainless steel pistons. The factory-installed coatings were without noticeable failures, blistering, or bare aluminum. The aluminum propellers are coated with Prop Speed, a foul-release coating intended for marine running gear. The propellers were true to the eye, tight to the splined shafts, and without frayed/folded blade edges, or pitting.

There were no indications of unusual electrolytic activity sighted on the outdrives and the hull's underwater metals, and the bonding systems and anodes were providing adequate cathodic protection. The anodes were roughly 50% depleted, and soon will be due for replacement.

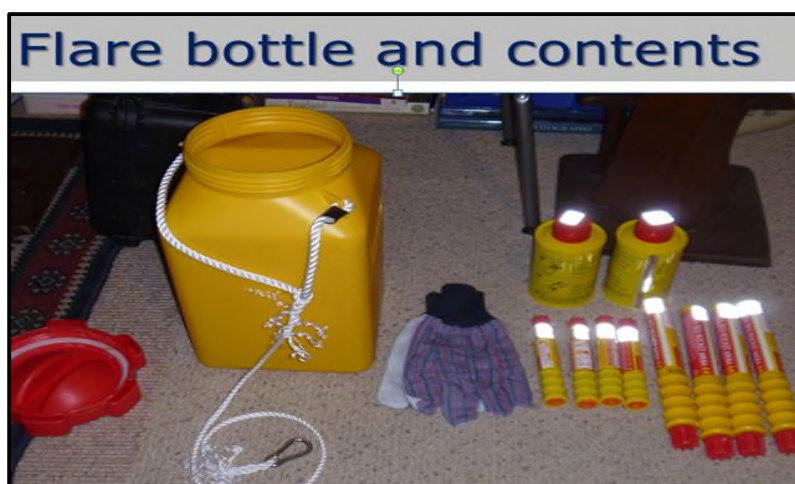
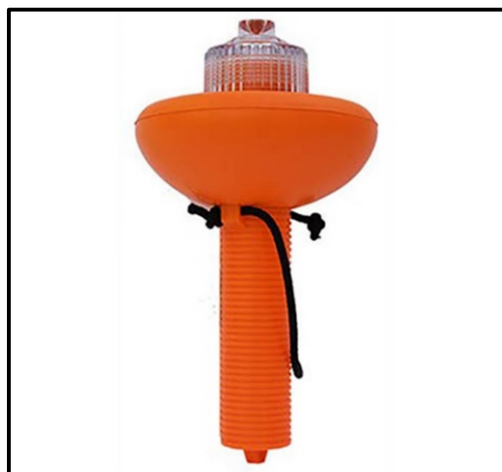
This photo shows a well-organized visual distress signal kit, and waterproof storage container. Including protective gloves and safety glasses. Note the dangerous ends of the flares are marked with reflective tape. Smoke or day signals, and handheld night signals, should be part of a complete flare kit. Additionally, white collision flares that can be displayed to bring attention to your vessel if it is not seen on radar or AIS of a large or commercial vessel, and also useful for lighting up the area in a MOB situation. It is important to treat flares with respect, store them well, and purchase SOLAS or LED flares. The USCG now approves electronic LED flares near shore. Carrying these LED flares should be considered, instead of traditional pyrotechnics. Pyrotechnic flares are extremely difficult to dispose of and have expiry dates.
