### **ROMEO PIER UPDATE: REPORT ON PERMITS, BIDS, FUNDING OPTIONS, AND PROPOSED TIMELINE**

# **ROMEO PIER EVALUATION REPORT**

**Prepared For  
SAN MATEO HARBOR DISTRICT  
El Granada, California**

**Prepared By  
MOFFATT & NICHOL ENGINEERS  
3000 Citrus Circle, Suite 230  
Walnut Creek, California**

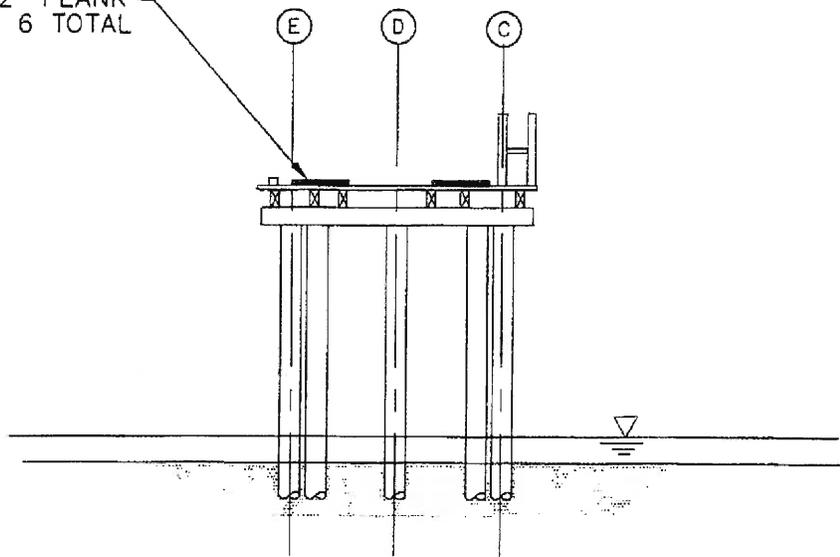
WHEEL PLANK IMPROVEMENT

ADD 3"x12" PLANK RUNNERS, 6 TOTAL

- **Guard Rail:** The pipe support along the western edge of the pier is in disrepair. We recommend that a new pipe support/guard rail be installed along the western side and a new guardrail be provided along the eastern edge to provide added safety.
- **Wheel Planks:** The low allowable truck weight is primarily due to the capacity of the deck planks. This situation can be improved to a large extent by the addition of wheel planks as shown in Figure 6. Loaded trucks should be restricted to the areas with wheel planks. These planks should be installed in areas where loaded trucks are expected to require access for normal fish handling operations on the pier.
- **Ladders:** Access ladders along the eastern side of the pier should be inspected and re-supported were necessary.

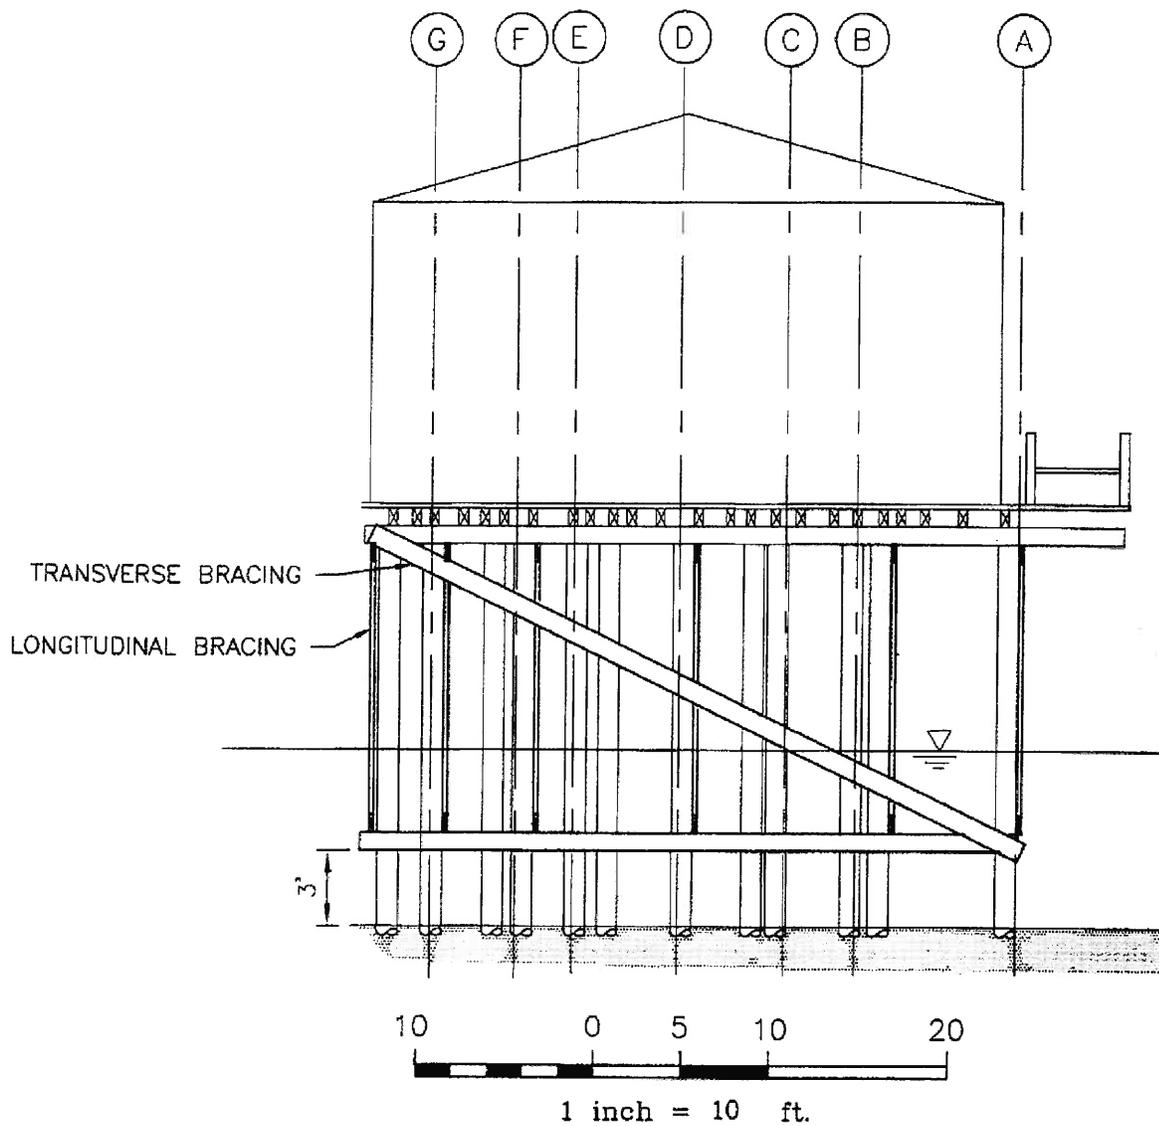
**FIGURE 7**

A significant deficiency of the existing structure is bending of the piles due to lateral load. This bending can be reduced by bracing the structure. Lateral loading from an earthquake can occur from any direction. Therefore, cross bracing would be required in both directions; transverse to the pier and longitudinal to the pier. Although not a practical solution for this pier because the piles do not align, this has been a relatively common method of bracing timber piers, and is included for cost comparison purposes. It would be difficult to implement on Romeo Pier because of the irregular pattern of the piling and resulting difficulty of installation. Due to the high bending stress in the piles, the bracing would be required to extend below the waterline, necessitating underwater work. Figure 7 illustrates this retrofit alternative.

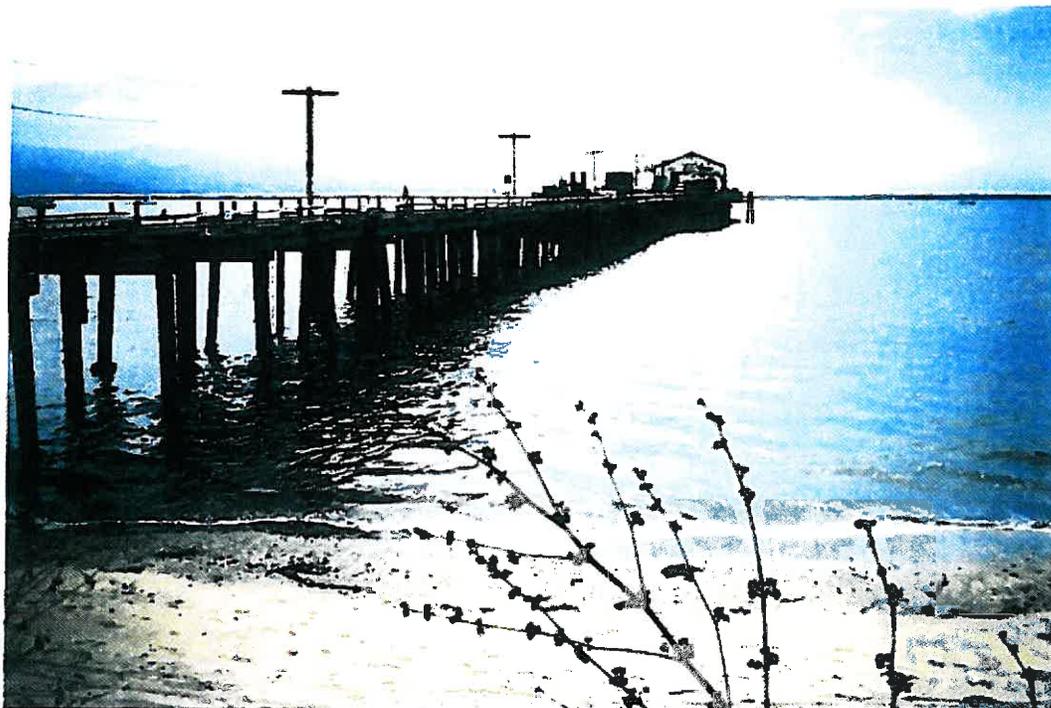
PIER FROM SHORE LOOKING SOUTH  
PHOTOGRAPH NO. 1

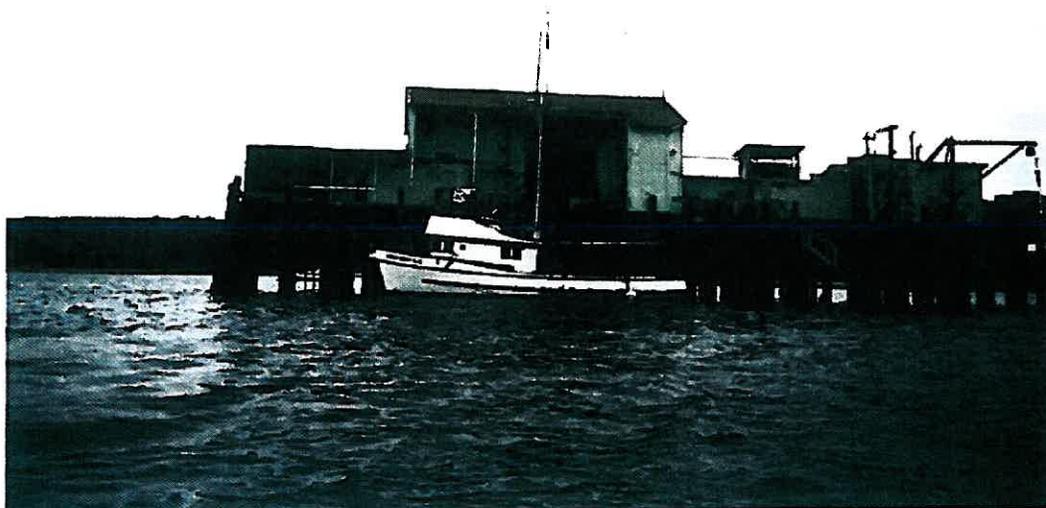
SOUTH END OF PIER LOOKING WEST SHOWING FISH HANDLING BUILDING  
PHOTOGRAPH NO. 2

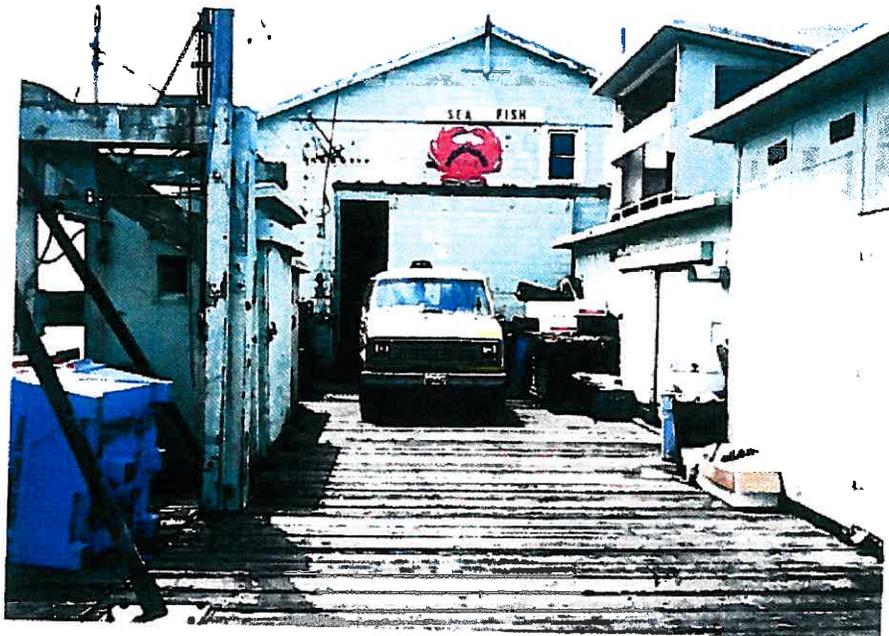
FISH HANDLING BUILDING  
PHOTOGRAPH NO. 4

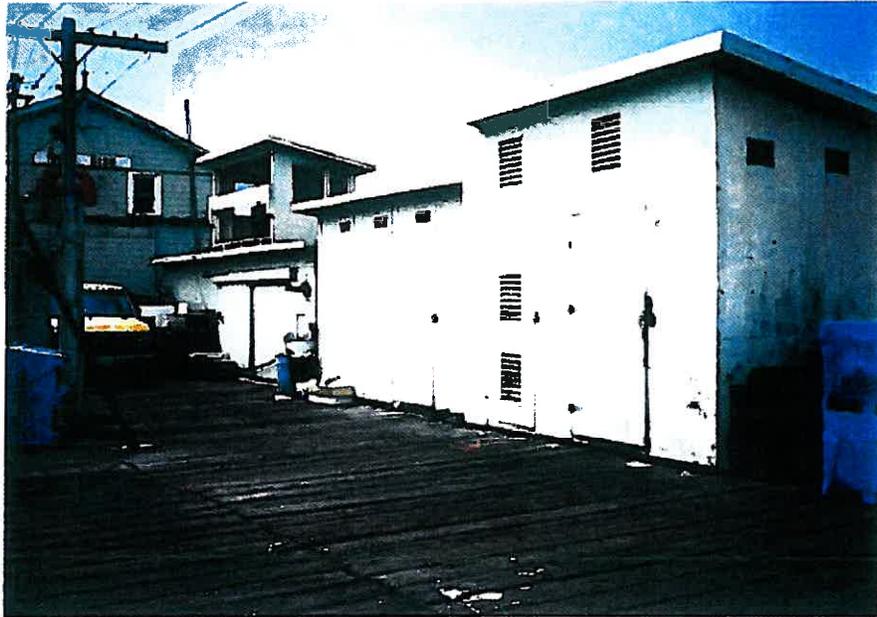
STORAGE ON DECK  
PHOTOGRAPH NO. 5

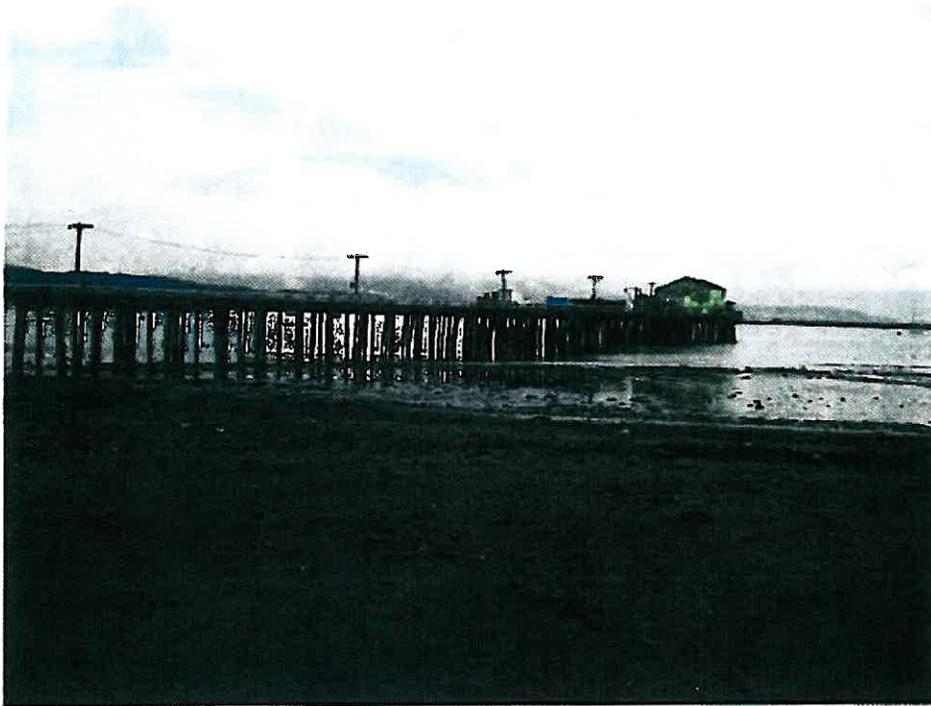
**Photograph 1 - Romeo Pier**

Romeo Pier is a timber framed and timber pile supported structure which is approximately 50 years old. The pier in plan consists of a 16 foot wide by 390 foot long approach section and a 35 foot wide by 250 foot long head section, for a total length of 640 feet. It is oriented in a north/south direction with the landfall at the northern end. A plan view, elevation and sections of the structure are shown in Figure 1. Grid lines are shown on the plan view of the pier. These grid lines are used as a reference system in this report to help identify specific locations being discussed in the text. It should be emphasized that the grid is an idealized representation of the pier, and the actual pier is skewed in many locations. The pier deck is at Elevation +13.8 ft relative to Mean Lower Low Water (MLLW). This relatively high deck elevation is because the pier was constructed before the breakwater was built and therefore at one time required clearance for storm waves. Total plan area of the pier is 18,000 square feet. Photograph 1 provides a general view of the pier structure.

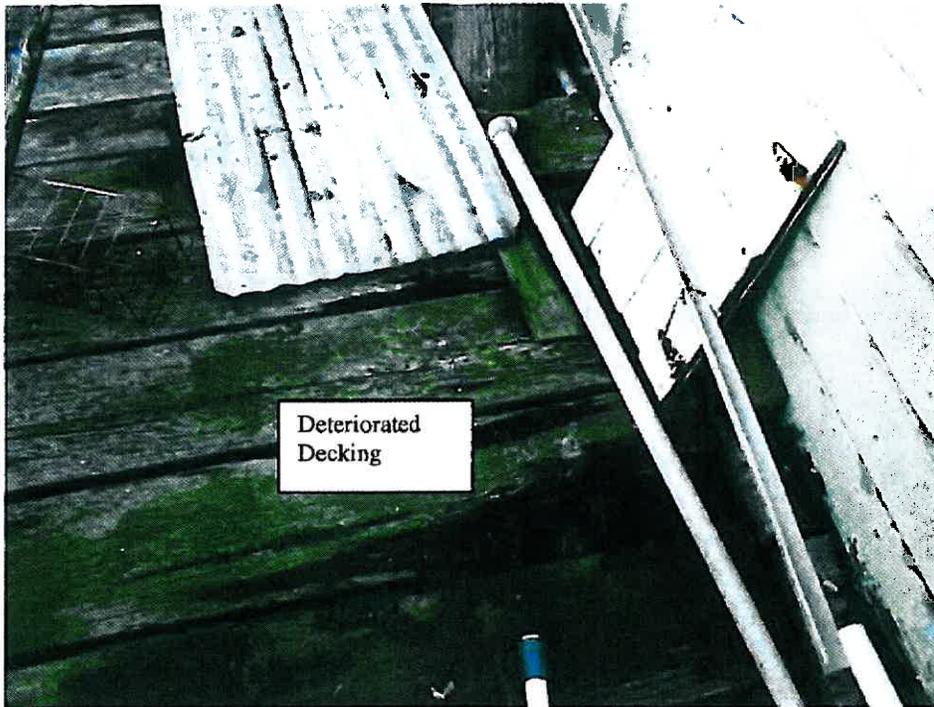
The overall condition of the decking is fair to good. Some members have recently been replaced. Splitting at the ends where deck members are nailed to stringers was observed and rotting of the deck members was observed at the end of the pier, particularly along the exterior walls of the building. Of particular concern is the west side of the building on that portion of the deck that cantilevers out from the deck (see Photograph 2).

**Photograph 2 - West Side of Building**
