## **CONDITION & VALUE SURVEY**

## **M/V 32' Harbor Patrol**

**Report #:** 26-158R  
**Date:** September 2, 2026  
**Owner:** San Mateo County Harbor District  
**Survey Requested By:** Chris Tibbe, [ctibbe@smharbor.com](mailto:ctibbe@smharbor.com)  
**Where Surveyed:** Clipper Yacht Harbor & Safe Harbor Sausalito  
**Afloat/Hauled:** Afloat & while hanging in the Travelift slings  
**Type:** Harbor patrol boat  
**Service:** Commercial/institutional  
**Home Port:** Pillar Point, CA

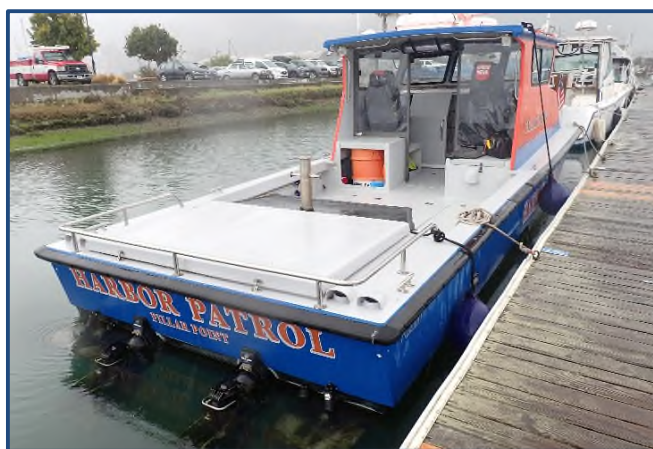
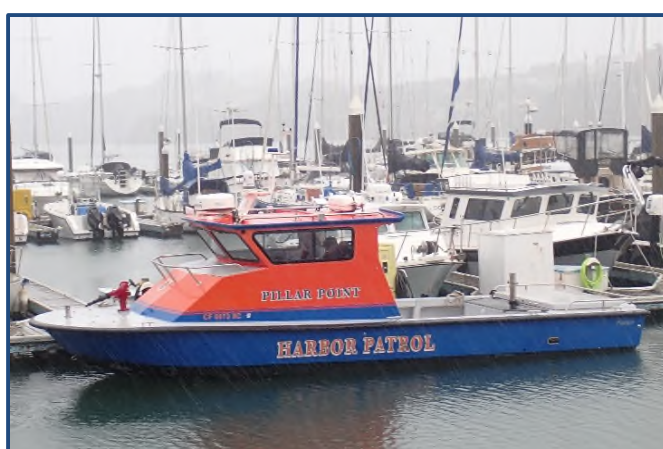
The deck layout consists of a large self-bailing working aft cockpit, with a pilothouse, and flush side and fore decks. The deck, cabin, and pilothouse structures are constructed with alternating

layers of molded fiberglass, with suspected closed-cell core in places for reinforcements. The cockpit bails through scuppers inset into the cockpit sides and bulwarks.

Visual inspection showed the structures in overall near-new condition, as result of the recent rebuild; without indications of physical harm, damage, or previous repairs. The structures were tap-tested with an 8-oz. plastic headed hammer; all returns were generally sharp, and there were no indications of outer-bond separations, delamination, or deteriorated core materials. The structures were spot-checked with a Protimeter Aquant moisture-meter; all readings were generally low, with no indications of water migration into the composite structures, or saturated core materials.

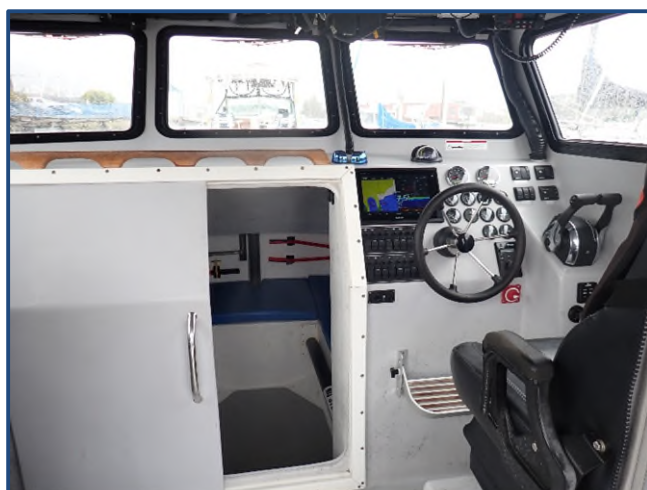
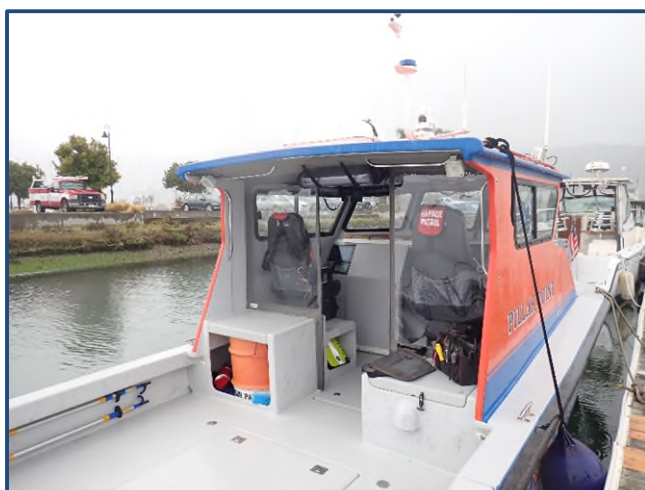
The interior accommodations consist of a cuddy cabin and pilothouse on the deck level. The cuddy cabin has a vee berth forward, and there are storage lockers aft to port and starboard. The pilothouse has an offset steering station to starboard; there are two pedestal seats, and storage lockers aft to port and starboard of a rear glass bulkhead/entryway. The interior, lockers and bilge spaces were clean, dry, and well ventilated. There were no indications of deck, hatch, or window leaks sighted in the interior. The pilothouse windows and windshields are constructed with SeaGlaze marine safety glass, and contained within anodized aluminum frames. The safety glass was clear, without occlusions or cracking. The frames were well attached to the structures.

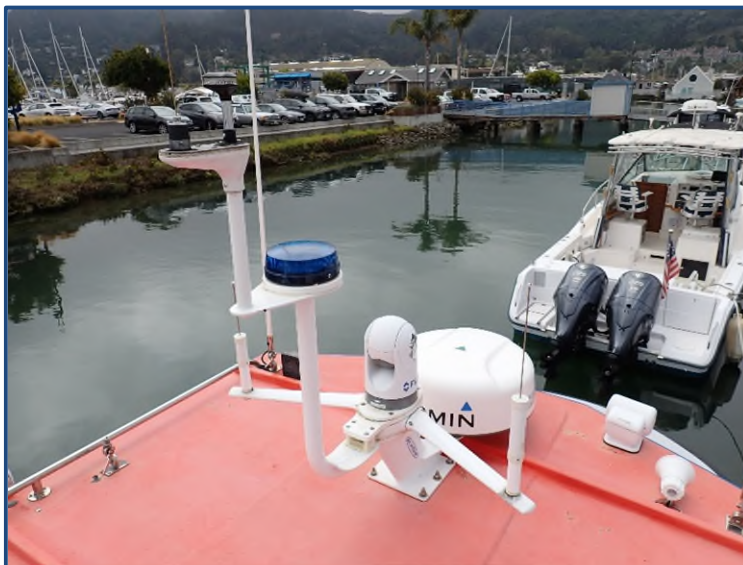
There is a Seaview painted aluminum light/antenna mast, which was in good condition with the coatings free of failures, no bare aluminum, and the mast well secured to the pilothouse roof. The stainless steel welded safety and hand rails were well secured to the decks, and free of bent or distorted tubing, or cracked welds. Likewise, the stainless steel mooring cleats, bow mooring bit, and stern towing bit were well secured, and without signs of strain or structural movement.

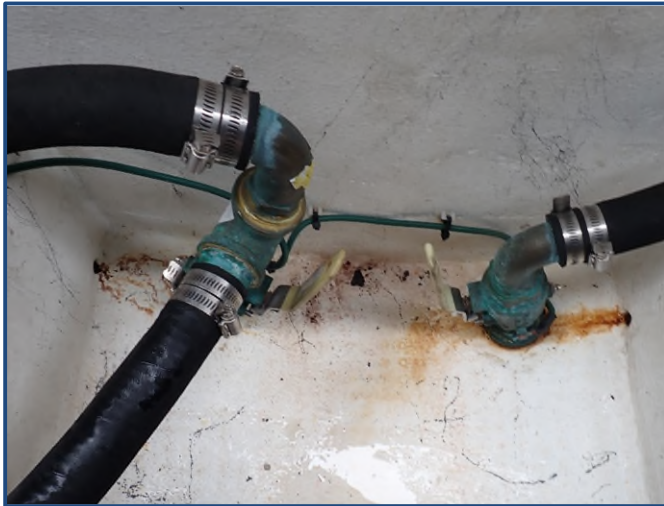
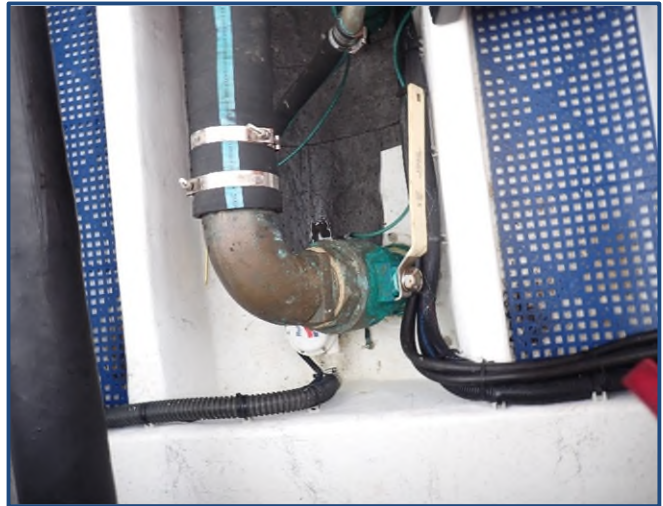
For sea-connections, the vessel relies upon Groco bronze inline ball-valves, coupled to threaded bronze through hulls. The ball-valves passed all tests, and were found in satisfactory and operable condition. The bronze threaded through hulls were without defects, corrosion, pitting, or seepage. The corresponding hoses have been replaced over the years, and were found in serviceable condition, where visible and inspected.

It is suggested to provide softwood tapered plugs tied to the through hulls, which could be used in cases of emergency failure of any sea-connection valves, hoses, or piping below the waterline. Furthermore, the plugs should be stored in plastic bags, to prevent them from becoming wet, and swelling before usage.

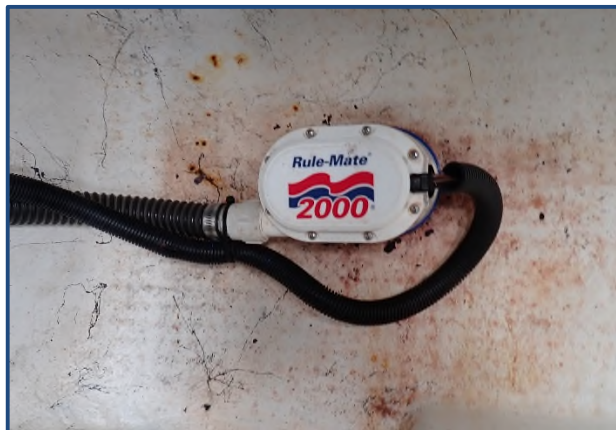
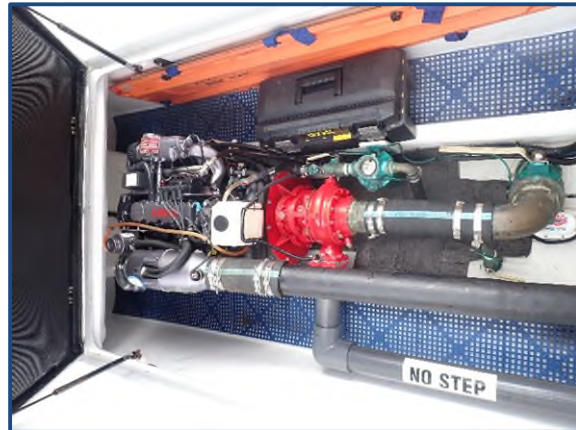
There is an institutional firefighting water cannon mounted on the foredeck, which is supplied with water via a high capacity 500-GPM impellor pump that is driven via a Kodiak four-cylinder gasoline powered engine. The pump and engine appeared in good operating condition, and well maintained. No testing of the water cannon, supply pump, or its engine were carried out.

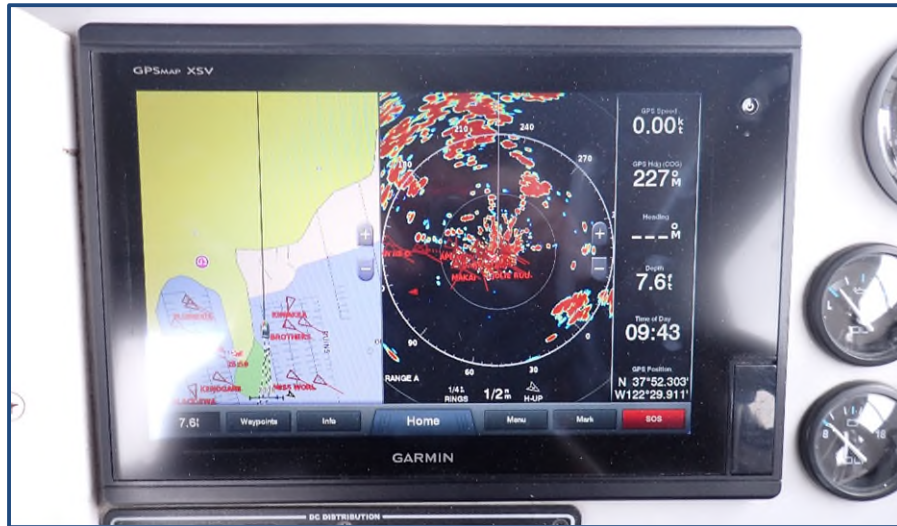
The vessel's electronic navigation systems have been upgraded. The heart of the system are the two Garmin GPSmap XSV multifunction navigation displays (MFD), which are interfaced to the various modules, transponders, transducers, senders, and the radar scanner via NMEA cabling, hubs and backbone. Testing the Garmin MFD showed them functioning normally in radar mode, and providing a clear digital image. When the MFD were tested in radar/chart overlay mode, they provided accurate vessel position, navigation information, and charting data.

The MFD are interfaced to a Raymarine AIS transponder, which showed AIS contacts as expected. The Garmin and Standard Horizon AIS/GPS/VHF radios powered up, and received clear transmissions from vessel traffic, channel 14. The vessel is equipped with police and public band radios, which likewise powered up and received clearly, to the extent they were tested.

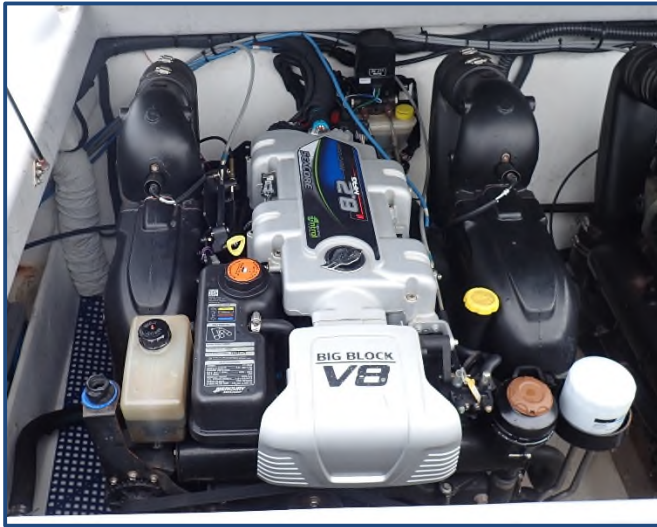
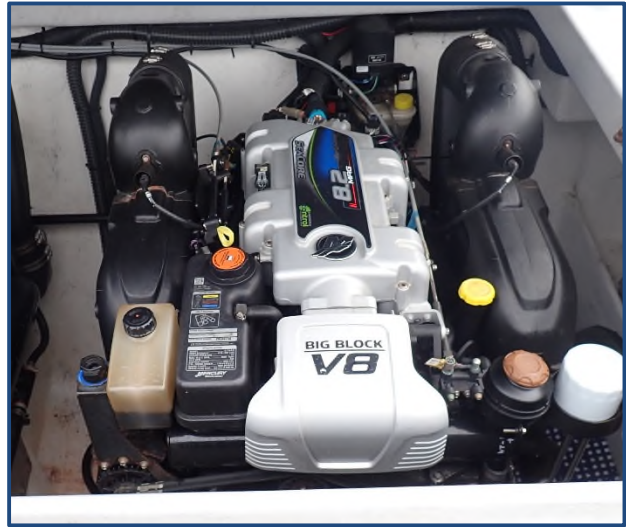
The vessel is powered via twin MerCruiser V-8-cylinder fuel injected four-cycle 8.2 liter engines, which are coupled MerCruiser Bravo 2 outdrives, that counter-rotate, three-bladed aluminum propellers. The engines are installed securely upon fiberglass composite longitudinal stringers and engine beds, with the use of custom stainless steel weldments.

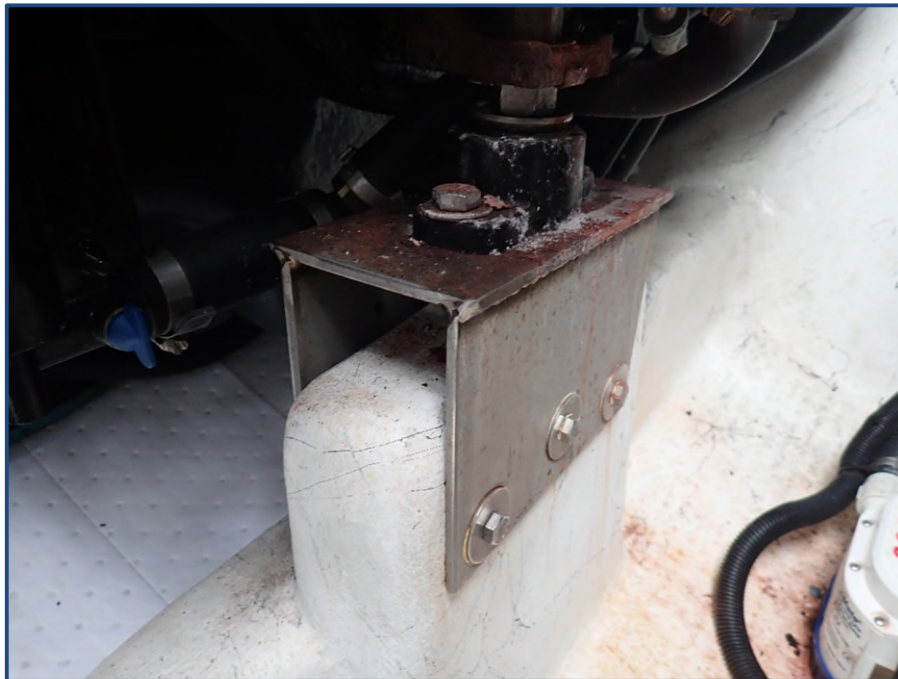
Tap-testing the engine stringers, and visual inspection showed no indications of cracking, delamination, or soft-core materials. The motor mounts and are sound and solid, with their bushings maintaining resiliency, and the adjusting workable, and rust-free. The engine hatch sound insulation was well adhered, and without signs of deterioration.

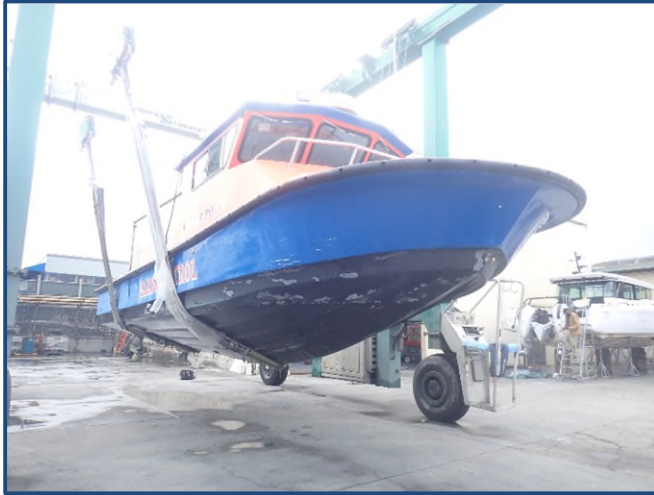
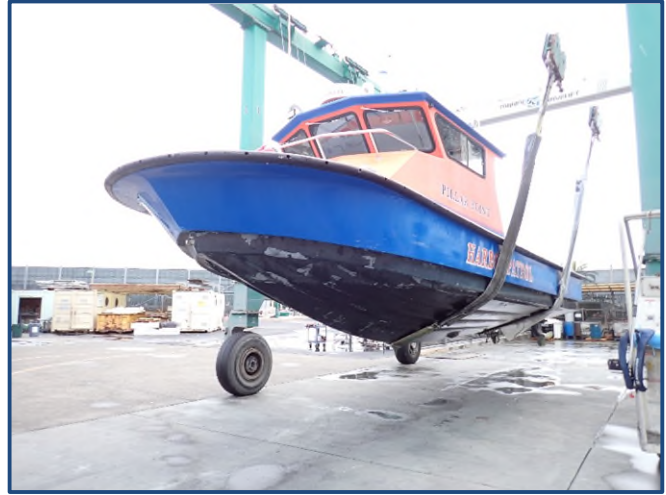
The hull is constructed of monolithic alternating layers of hand-laid molded fiberglass. The topsides are protected with a heavy rubber D-rub-rail, installed at the shear. The topsides have spoonsons just above the waterline; they are flat aft and flare forward, with a spoon bow and a vertical transom. The underwater hull has vee sections, with multiple lifting strakes and hard chines, and it flattens aft slightly; there are twin MerCruiser outdrives counter-rotating aluminum three-bladed propellers, and stainless steel Lenco trim tabs, with mechanical actuators.

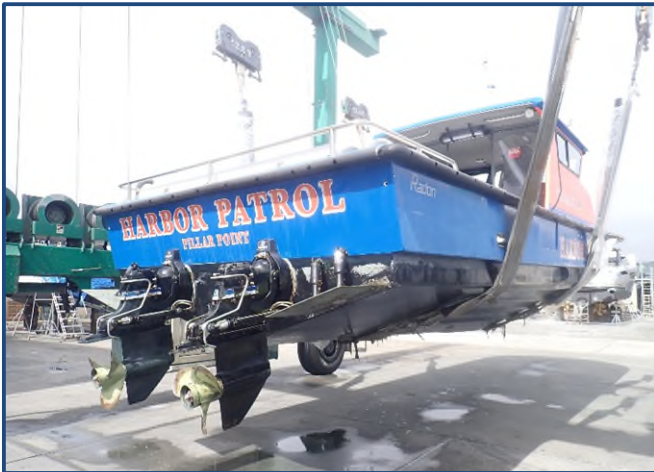
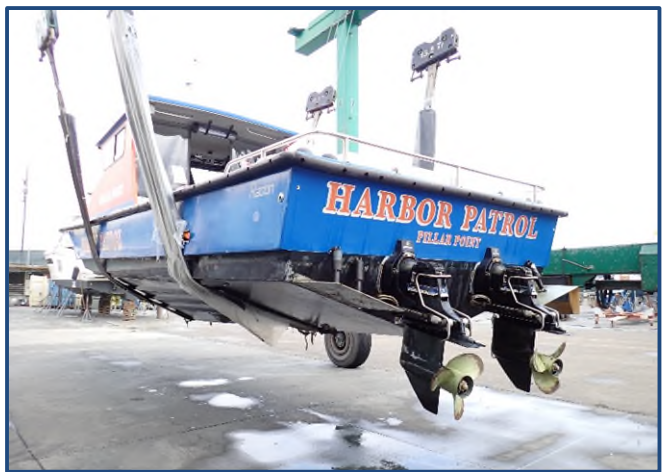
The topsides were fair, and free of indentations, physical harm, or damage. The rub-rail was without impact damage, and secure. The topside gelcoat was in fair condition, without noticeable wear, or significant oxidization.

Likewise, the underwater hull was fair, free of indentations, and without indications of previous repairs, or grounding. The underwater hull showed no indications of osmotic blistering. The antifouling paint had some minor detachment, and a few isolated areas of bare gelcoat, and likely is due soon for recoating. To assure improved bottom paint adhesion, extra prep work should be performed. The underwater hull was tap-tested with an 8-oz. ball-peen hammer, and all returns were generally sharp, with no indications of delamination, outer-bond separations, or compromised core materials.
