Oyster Point Marina

Updated Marina Facility Condition Survey Report

Prepared for:
San Mateo County
Harbor District

May 2021

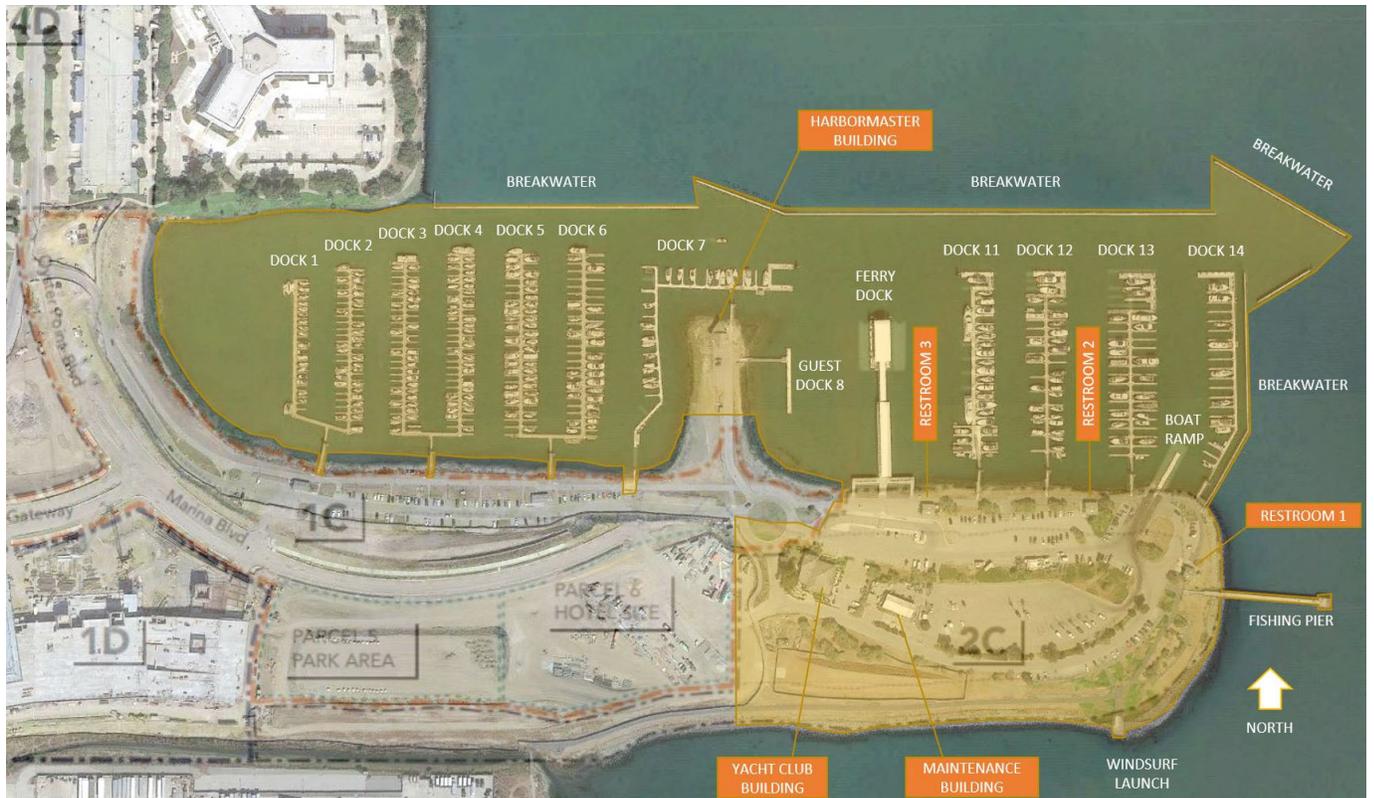
The facilities within Oyster Point Marina maintained by the District include approximately 468 boat slips serving recreational boaters, a guest dock, boat launch ramp, a windsurf launch area, boater and public restrooms, the harbormaster and maintenance buildings, parking lots, landscape areas and portions of the San Francisco Bay Trail. The extent of this inspection includes the harbor district facilities within the breakwater and portions of the highlighted areas of the peninsula shown below in Figure 1.

Figure 1 - Oyster Point Marina (aerial: Google Earth Pro image Sept 2020)

The west half of the Oyster Point peninsula is undergoing significant changes on the landside with the construction of the Kilroy Oyster Point Redevelopment Project. The west half of Marina Boulevard, the entrance road to the harbor facilities which runs from Oyster Point Boulevard, has recently been realigned. The unaffected portion of Marina Boulevard on the east half of the peninsula runs roughly from the halfway point of the peninsula in line with the spit, to just south of the yacht and maintenance buildings, and along the south side of the upper parking lot to the launch ramp at the northeast corner of the peninsula (see Figure 1 highlighted area).
