Pillar Point Harbor Water Quality Program Update

San Mateo County Harbor District Board of Commissioners Meeting
February 21st, 2018

SAN MATEO
RESOURCE
CONSERVATION
DISTRICT

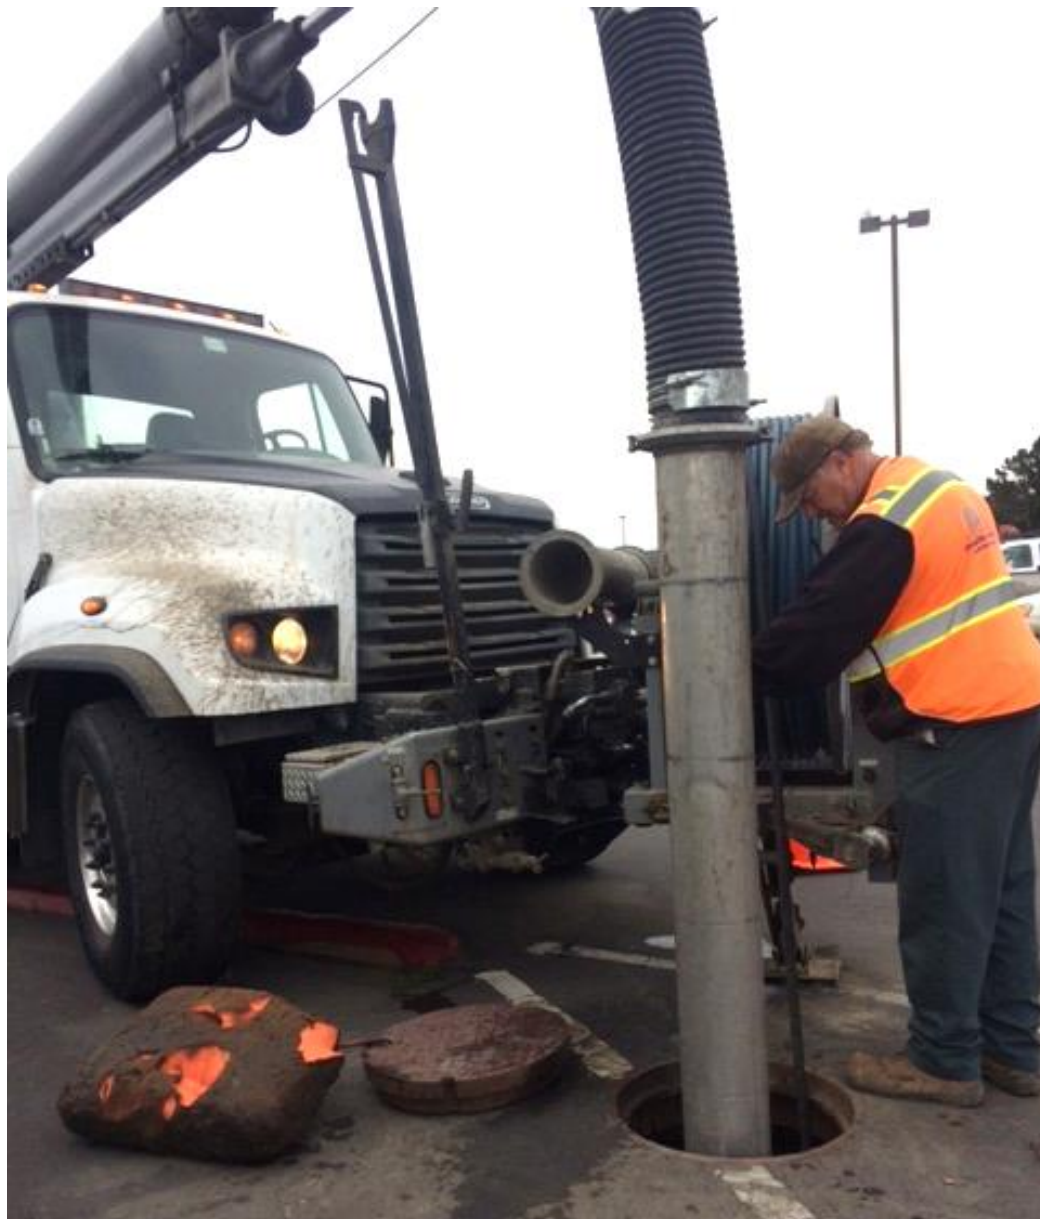
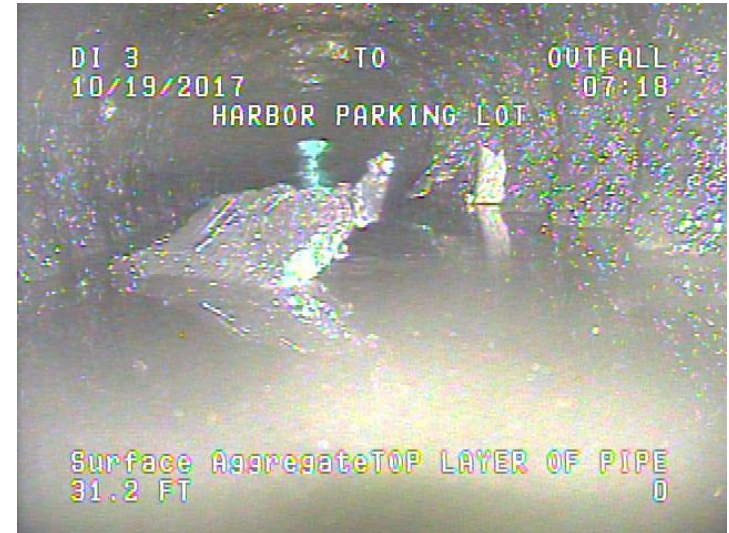
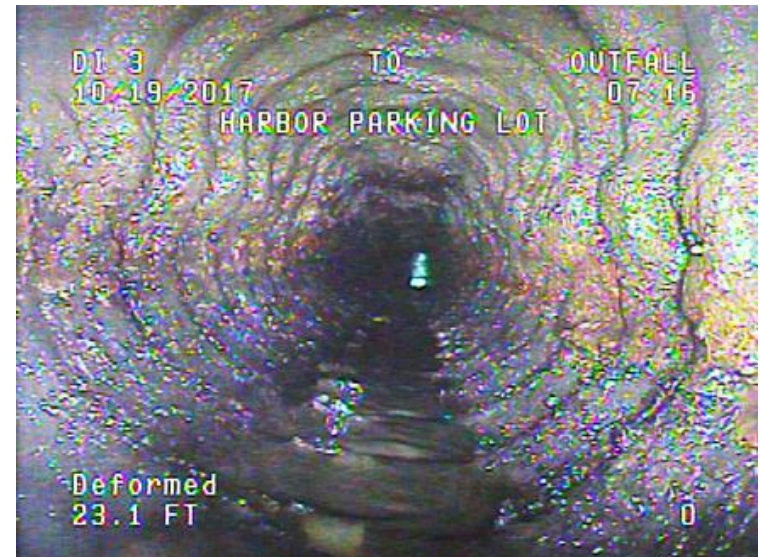
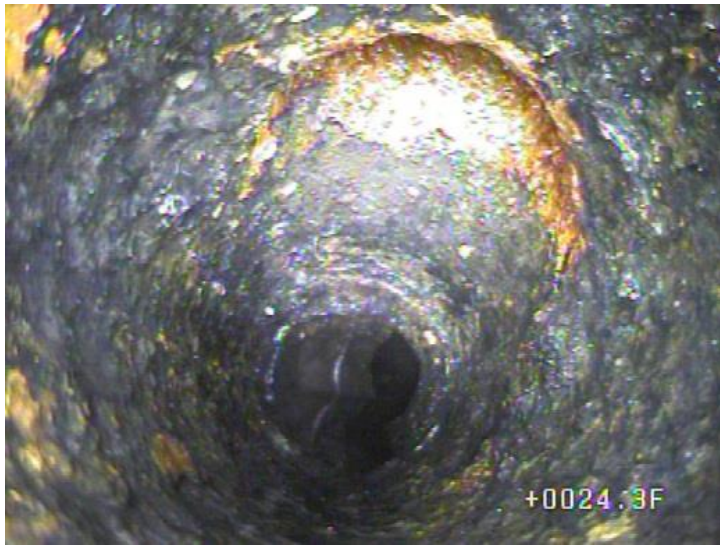
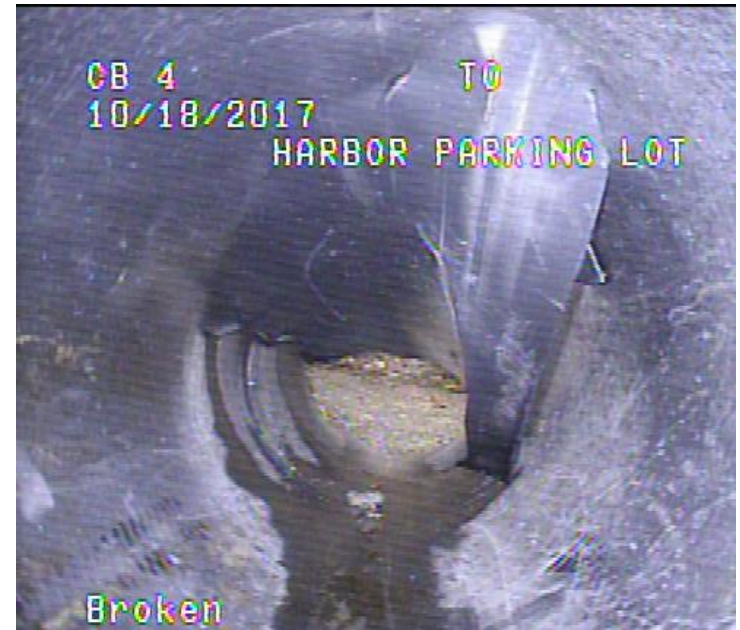
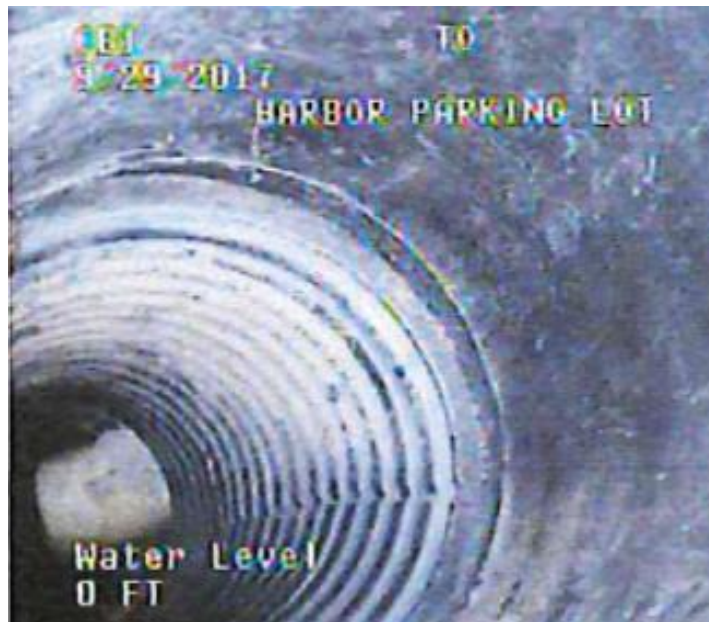
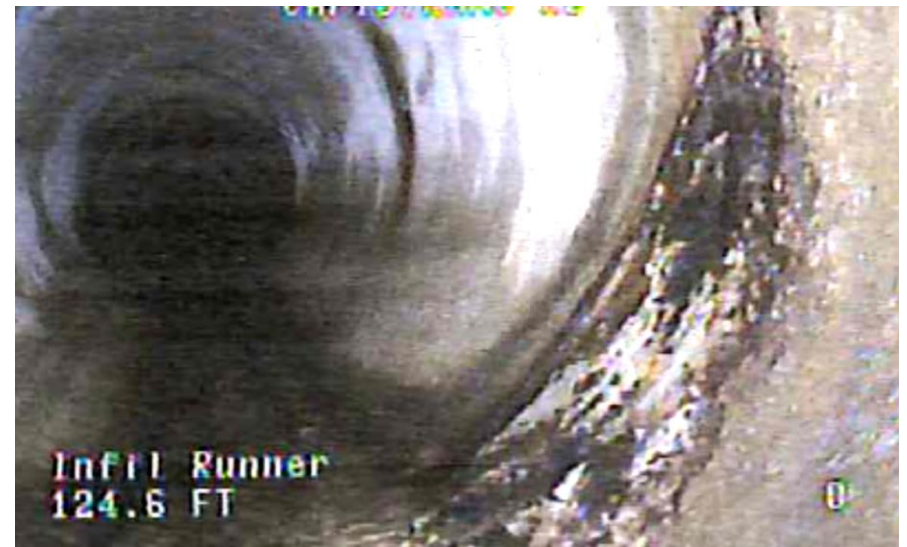
What we found...

- Condition and layout of stormwater systems
- Found specific vectors & aggravators of pollution
 - HD system- washdown connection, broken pipes, FOG/debris, remnant lines
 - County system- groundwater infiltration and unknown connections and pipes
- Tested several sewer lines with dye and didn't see evidence of leakage into stormwater system or harbor

- Fix broken/failing stormwater pipes & FOG/debris issues
- Map, clean, & inspect rest of harbor stormwater system
- Continue working w/ partners (County & Surfrider) to identify sources of bacteria entering the harbor
- Continue educating tenants & harbor staff about best practices
- Continue scoping and implementing solutions (ex: sealing washdown connection) and providing technical assistance

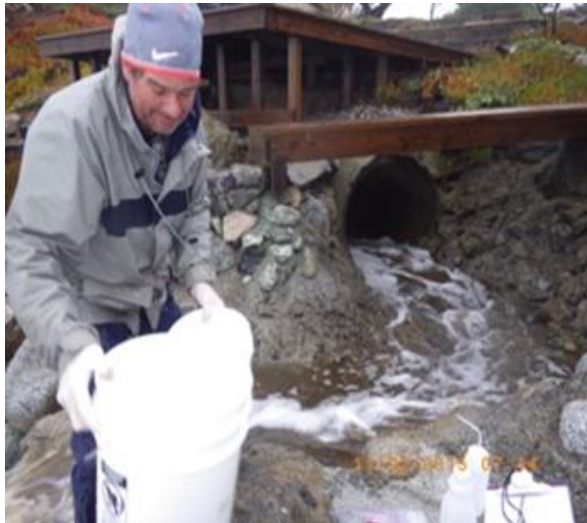
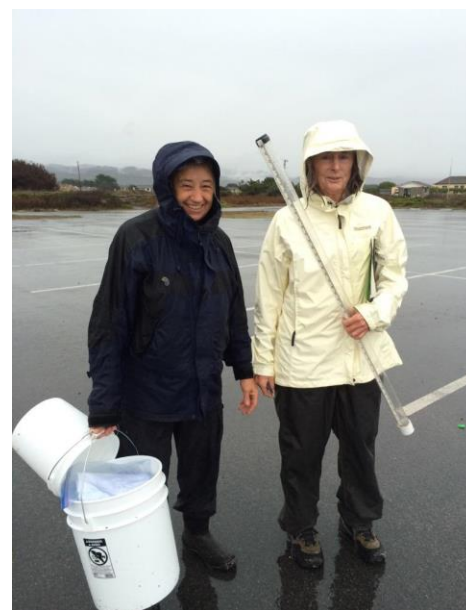
First Flush Summary

Pollutant	Exceedance Rates at Historic Sites (2008-2017)	Locations of most exceedances and highest values
Bacteria	98%	Capistrano Street, Surfers South
Orthophosphate	72%	West Point, El Granada Ditch
Copper	55%	West Point
Zinc	30%	West Point

Lead, nitrate and TSS = 0%
